# **INSTALLATION RESTORATION PROGRAM**

# INSTALLATION RESTORATION PROGRAM PRELIMINARY ASSESSMENT

104th TACTICAL FIGHTER GROUP MASSACHUSETTS AIR NATIONAL GUARD BARNES MUNICIPAL AIRPORT WESTFIELD, MASSACHUSETTS

March 1988

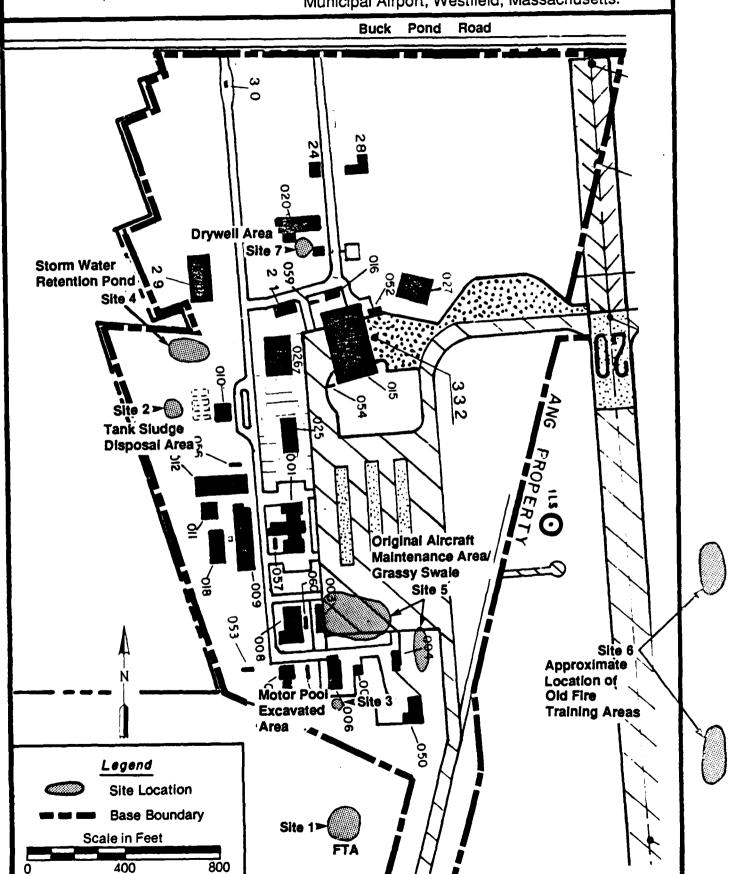
# Figure 3.

The Fire Training Area (FTA) is located north of Runway 15, just outside the Base (see Figure 3). Although this site is not within the Base property, it is being addressed in the Preliminary Assessment because the ANG has been the primary user of this site, and as such holds ultimate responsibility for any waste found there.

Location of Sites at Massachusetts ANG, Barnes Municipal Airport, Westfield, Massachusetts.

According to interviews with Base personnel, the Retention Pond receives effluent from the Hangar and the Maintenance Building (Building No. 020) areas (see Figure 3). During the site survey, there were no observed signs of contamination (i.e., vegetation stress, odor). However, in 1961, there was a con-

This site is located adjacent and south of Building 020 (see Figure 3). According to Base personnel, two dry wells were located at this site; although there was no confirmed evidence of hazardous waste disposal or spills at the site. However, based on previous information, dry wells have been used for disposal of shop wastes at other installations and it was reported that wastes may have been disposed of at this site on occasion. Based on the information available through the Preliminary Assessment, a HAS cannot be determined. However, additional IRP investigations at this site are warranted and should be undertaken.
